**MINERSVILLE DAM NO. 4**

**NDI NO. PA-00675  
DER NO. 54-39**

**PHASE I INSPECTION REPORT  
NATIONAL DAM INSPECTION PROGRAM**

Name of Dam: Minersville Dam No.4, NDS NO. PA-00675  
State & State No.: PENNSYLVANIA, 54-39  
County: SCHUYLKILL  
Stream: DYER RUN  
Date of Inspection: November 2, 1978

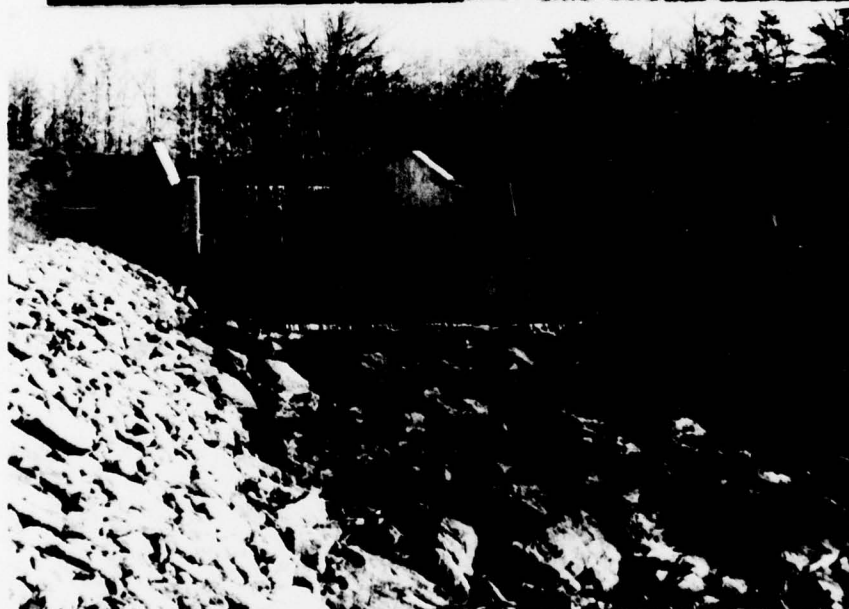
The appurtenant structures for this dam include the spillway, and the 24-inch concrete encased pipe and a valve house. The spillway, spillway outlet channel and stilling basin are in good repair. Recent guniting of the concrete walls and slopes provide a reasonably smooth unobstructed flow path. Visual observations indicate a stable structure. The stilling basin contains energy dissipation blocks and will provide protection of the downstream channel.

Drop Structure  
Stilling Basin

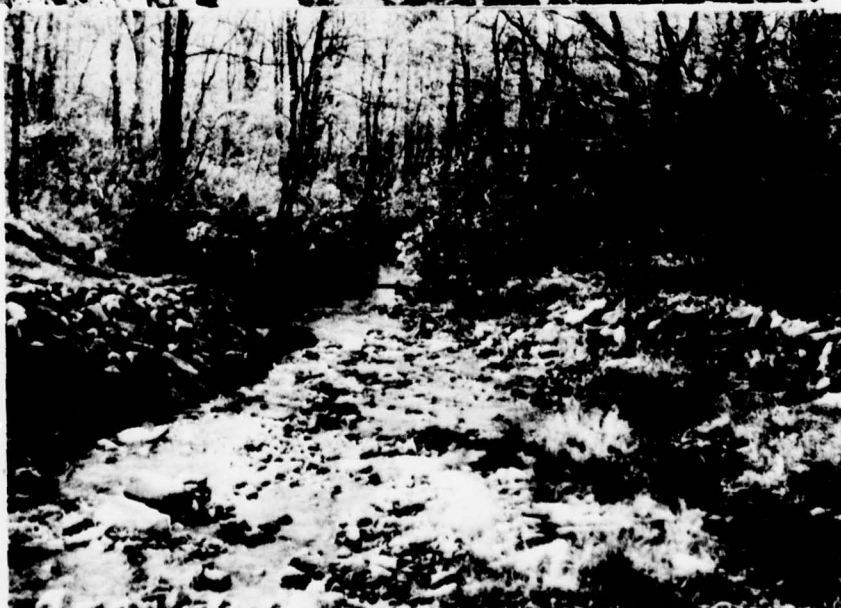
The spillway, spillway outlet channel and the stilling basin are all in good condition. The spillway is a broad crested weir with a length of 65 feet. The concrete surface of the slabs, weir and abutment walls have been recently (1974) gunited and have a good appearance. The stilling basin is a recent improvement to the spillway and outlet facilities and is in excellent condition.

Spillway Outlet  
Channel

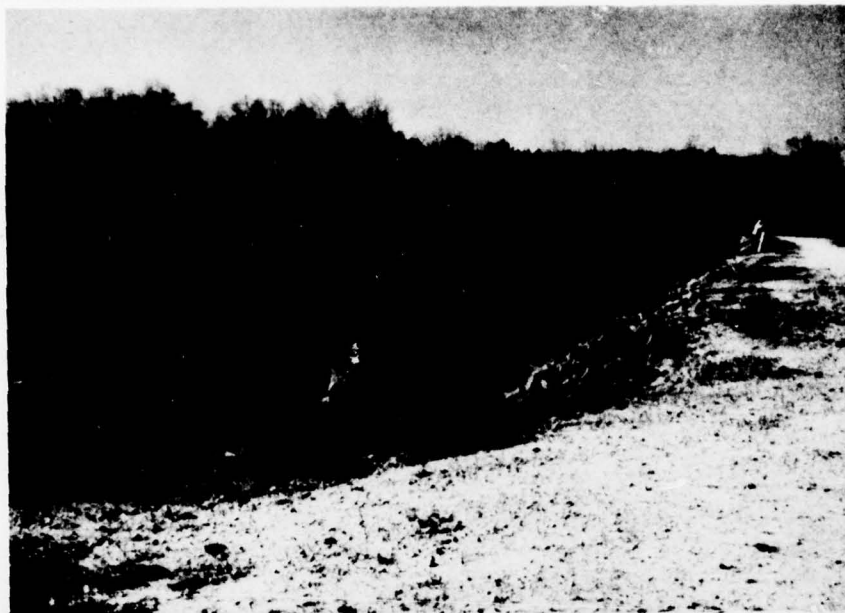
The upstream and downstream slopes of the embankment are in good condition. The downstream slope is composed of dumped rock. The upstream slope surface is composed of sand and gravel over dumped rock to the waters edge. The top of the embankment is covered with a gravel surface and provides a good roadway surface as access to the spillway area.

Inspection of the downstream slope did not reveal any seepage from the slope surface. At one location near the center of the dam and to the left of the valve house, there is an exposed drainage collection point for seepage control at the toe of the embankment. The area is surrounded with dumped rock and an 8-inch steel pipe leads from this area to the outlet channel of the blowoff pipe. The seepage was observed to be small (less than 2 gallons per minute) and clear and is apparently under control.

Downstream Slope  
and  
Valve House

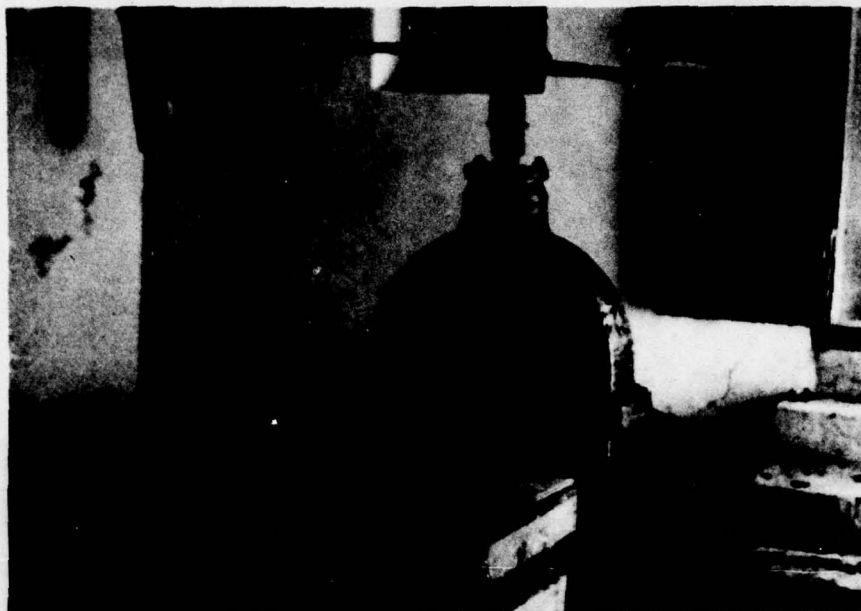
The valve house contains the controls for discharge of the outlet. The valves in this structure are greased regularly, are operated frequently and are in good condition.

The 24-inch outlet pipe is indicated as being encased in concrete and although not observed, is apparently in good condition. The outlet discharge is controlled in the valve house at the downstream toe of the embankment. All valves are operable and appear to be in good condition. There is no upstream control on this pipe.

Blowoff Control Valve

1. Continue the present operational and maintenance procedures regarding control of growth on the embankment slopes and the lubrication and operation of the valves in the valve house.
2. Develop and implement a formal surveillance and downstream warning system to be used during periods of high or prolonged rainfall or during other emergency conditions.
